PREVENT GAPS IN CEILING DUE TO UPLIFT

WESTERN WOOD
TRUSS ASSOCIATION
OF BRITISH COLUMBIA

Technical Memo: Partition Separation

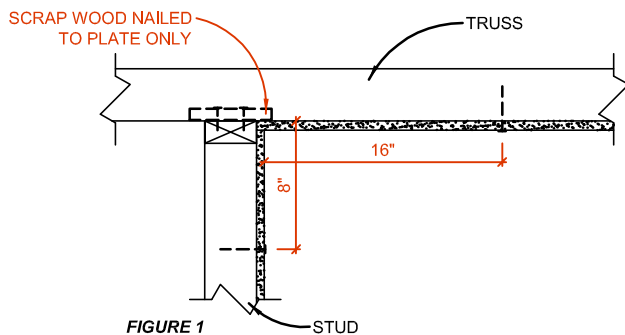
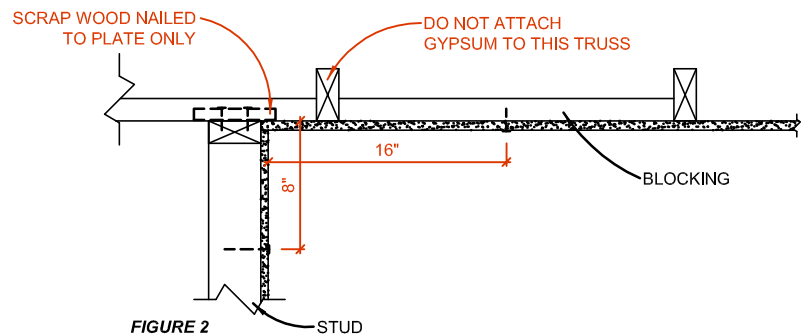
Partition separation shows as gaps that develop between interior partition walls and ceilings or floor finishes, usually characterized by opening in winter and closing in summer. Partition separation is usually worse during the first year after construction when the house is drying out.

Tests have determined that when a pitched truss in an attic has its bottom chord buried in insulation, it remains relatively warm and dry. The top chord however is exposed to the attic relative humidity and therefore will be colder and wetter than the bottom chord in winter months. The top chord will expand relative to the bottom chord, and the result is an upward bow in the bottom chord. If the walls are firmly fastened to the trusses, the whole partition may also be lifted. **Do not alter the trusses in any way**; this movement is of no structural concern with respect to the trusses. **Don't pull trusses down to the plates**.

Insist that the drywall contractor use floated corners at interior non-bearing walls for instance as illustrated in Figures 1 & 2 below. Note that the first row of fasteners should be doubled to prevent pull-through.

As an alternative, crown molding may be fastened to the ceiling only, so as to allow free movement of the ceiling relative to the wall and at the same time covering any gaps.
